Strengthening Capacities in the Western Balkans Countries to Address Environmental Problems through Remediation of High Priority Hot Spots

Environmental Hot Spot Serbia Remediation of the Grand Backa Canal

Monitoring of surface water and sediments quality in the Grand Backa Canal

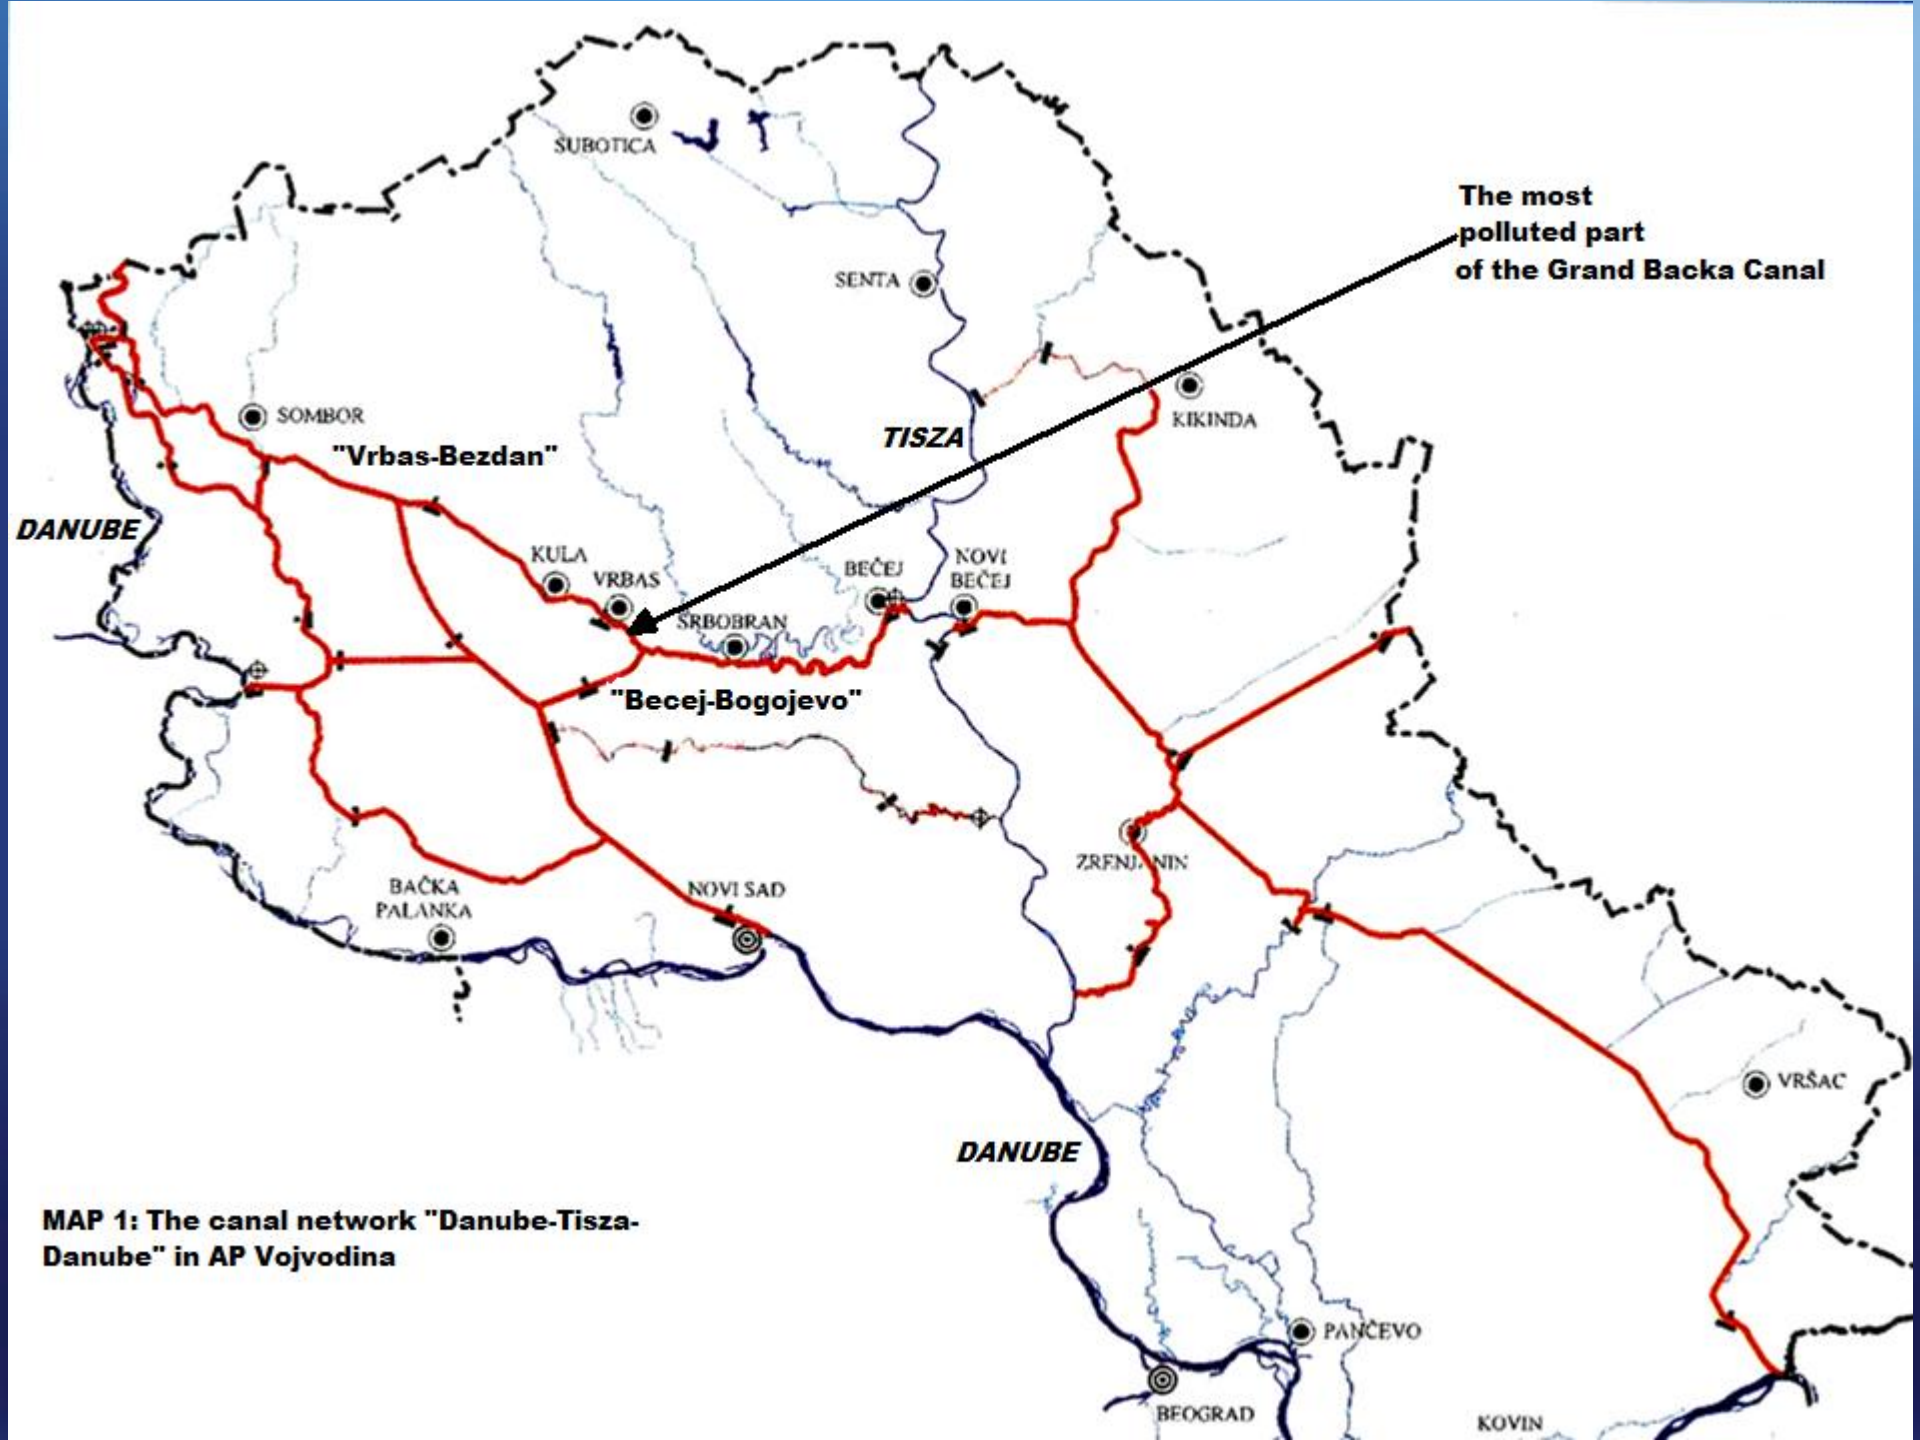
MAP 1: The canal network "Danube-Tisza-Danube" in AP Vojvodina

The most polluted part of the Grand Backa Canal

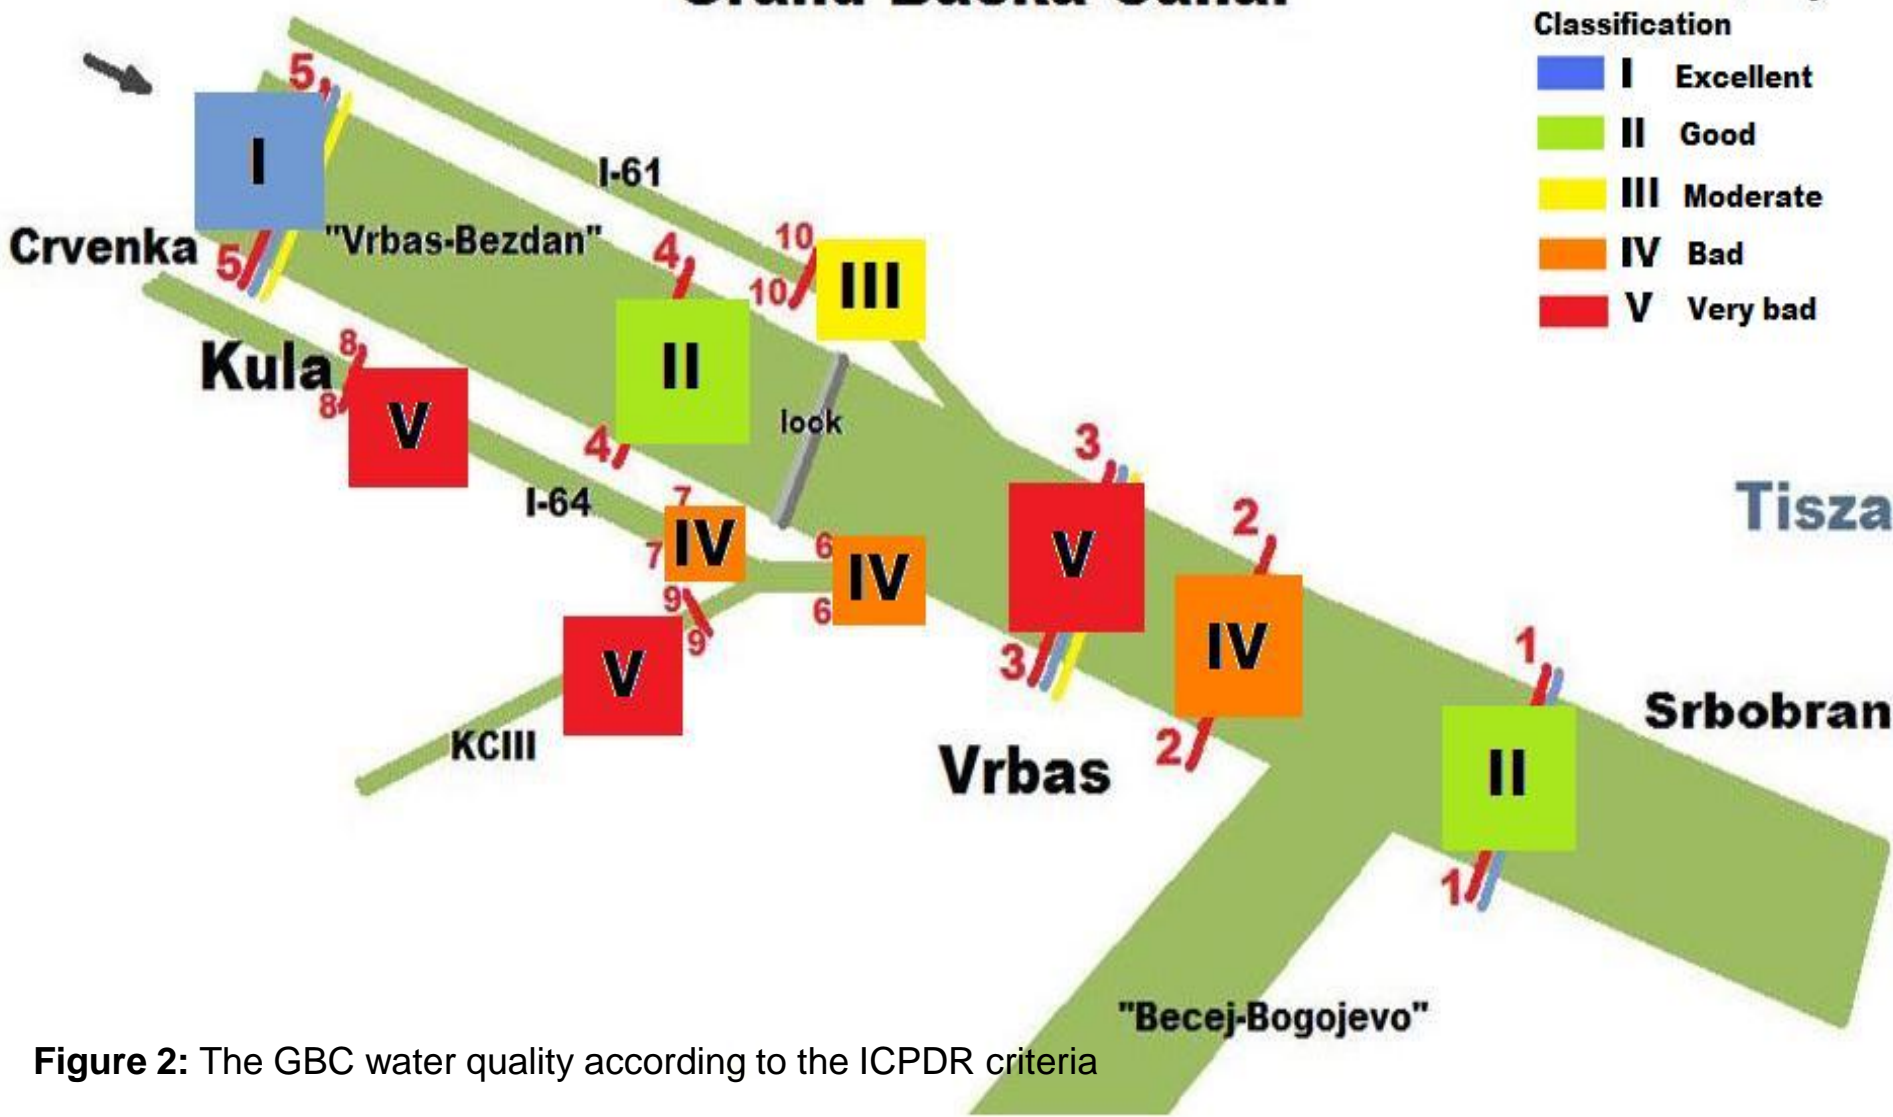
Figure 2: The GBC water quality according to the ICPDR criteria

- Waste waters and limited water that flows in the GBC network cause sedimentation of suspended matters, heavy metals, biodegradable organic matters, mineral oils and fecal microorganisms in extremely high concentrations.
- Water Quality: profiles 3, 8 and 9 are extremely polluted as shown by microbiological, physical-chemical and chemical parameters that are equal to sewerage water values (Figure 2).
- Examples on slides 17-20

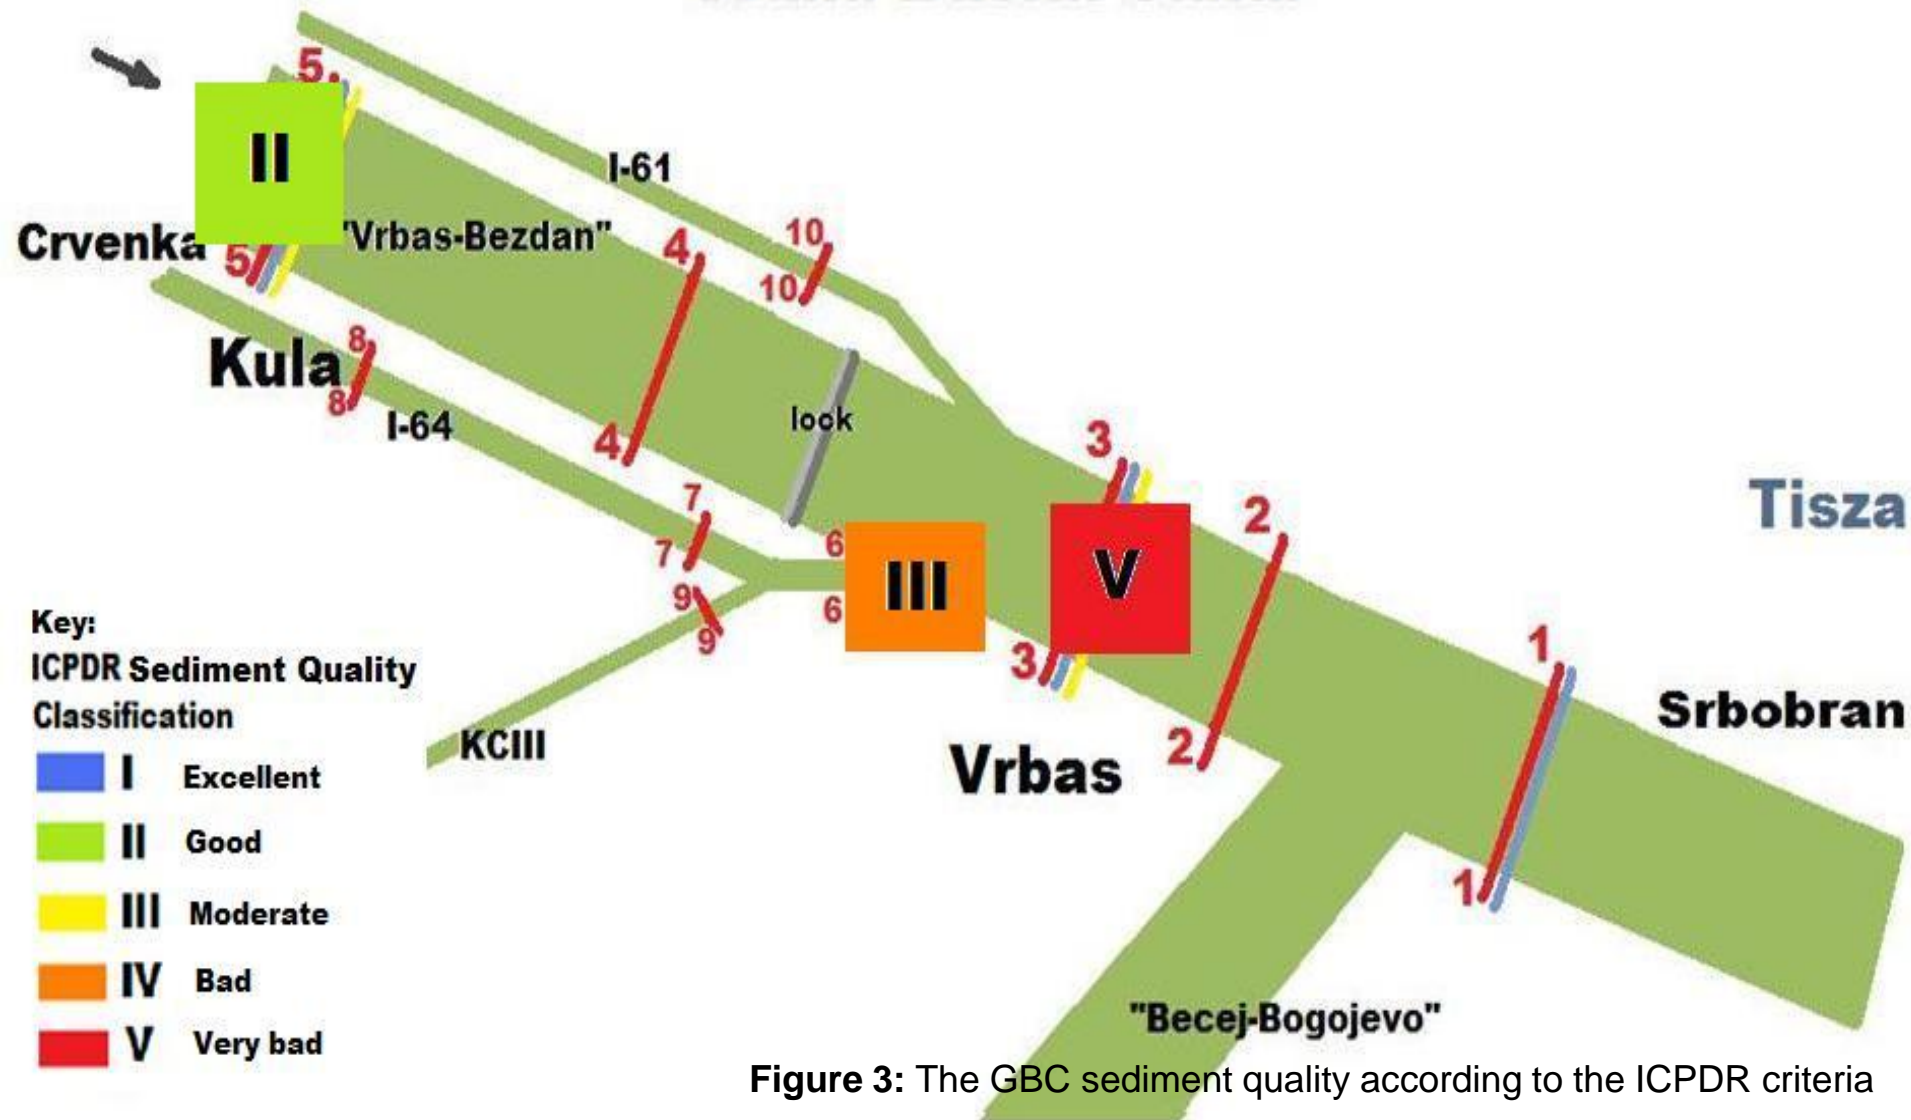
Figure 3: The GBC sediment quality according to the ICPDR criteria

- Assessed at profiles 3, 5 and 6, as shown in Figure 3.
- Profile 3 is the most polluted, with pollution mainly represented by a composite of soil and organic matter with a high heavy metals content (especially Zn, Cu and Cr in deeper layers of sediment), mineral oils and nutrients. Anaerobic conditions for decomposition of organic matters cause high content of sulphides.
