Strengthening Capacities in the Western Balkans Countries to Address Environmental Problems through Remediation of High Priority Hot Spots

Environmental Hot Spot Serbia Remediation of the Grand Backa Canal

Monitoring of surface water and sediments quality in the Grand Backa Canal

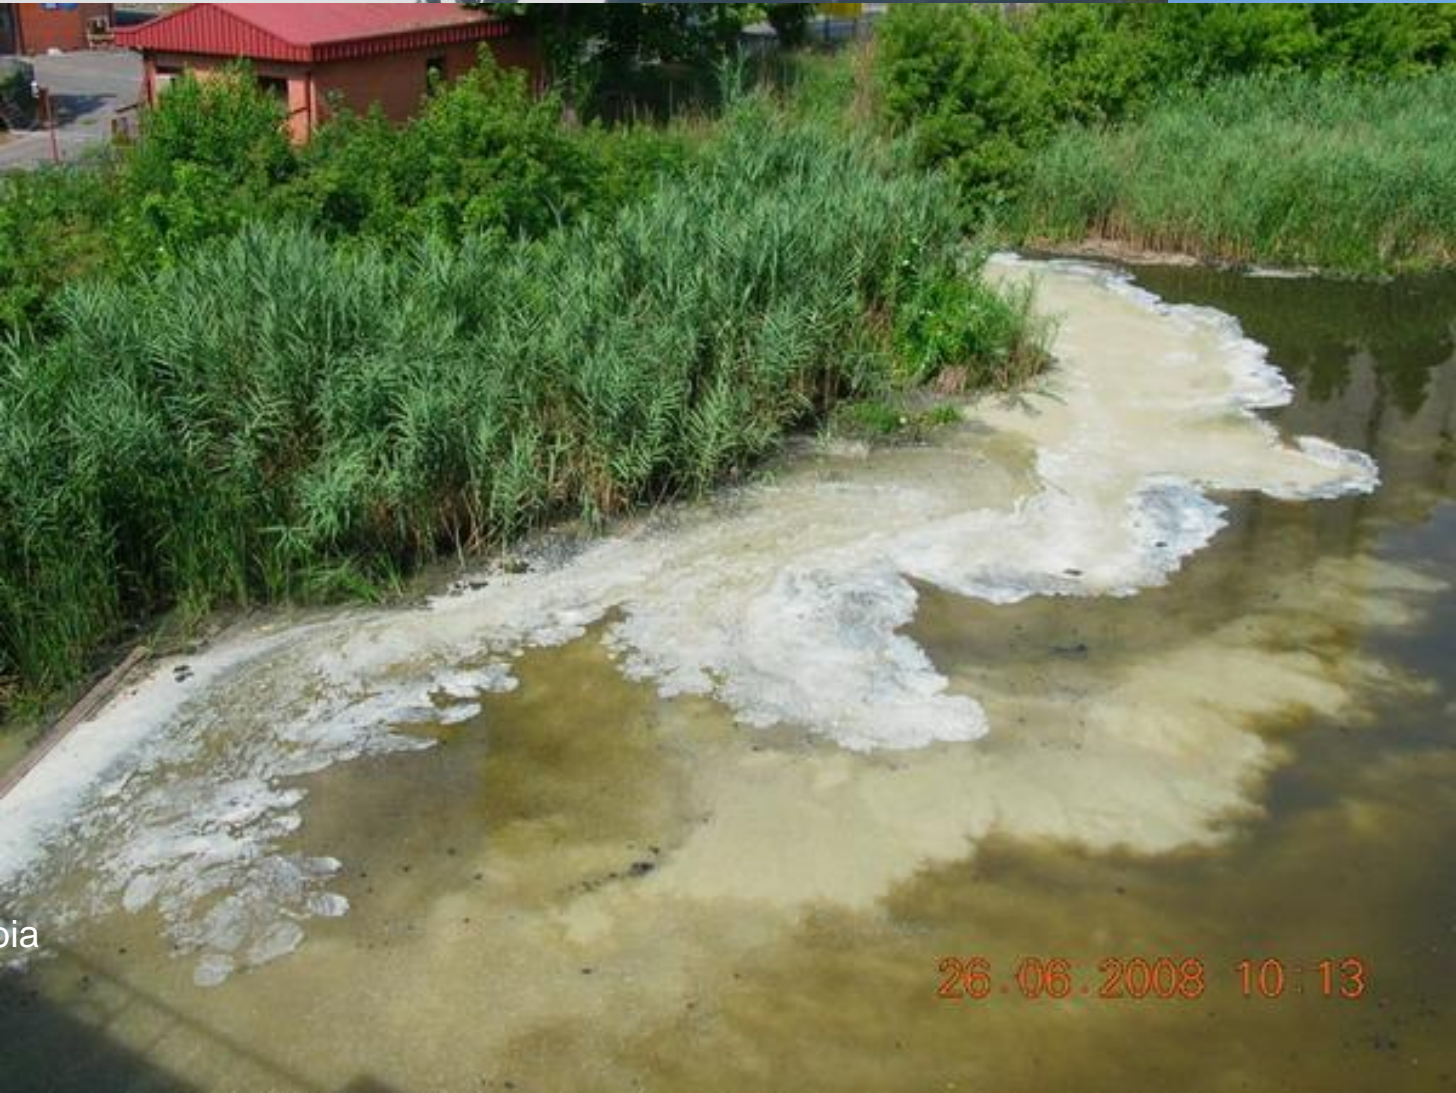
Photos 1-4: UNDP Serbia

- Cadastre of polluters registers 22 polluters
- Most of the polluters discharge untreated waste water into lateral canal I-64 and subsequently into the GBC
- The biggest polluters are: meat industry “Carnex” with its “Farmacoop” pig farm in Vrbas, sugar refineries in Vrbas and Crvenka, communal waste water from Vrbas and Kula, cooking oil factory “Vital” in Vrbas, metal and leather processing factories in Kula and others.

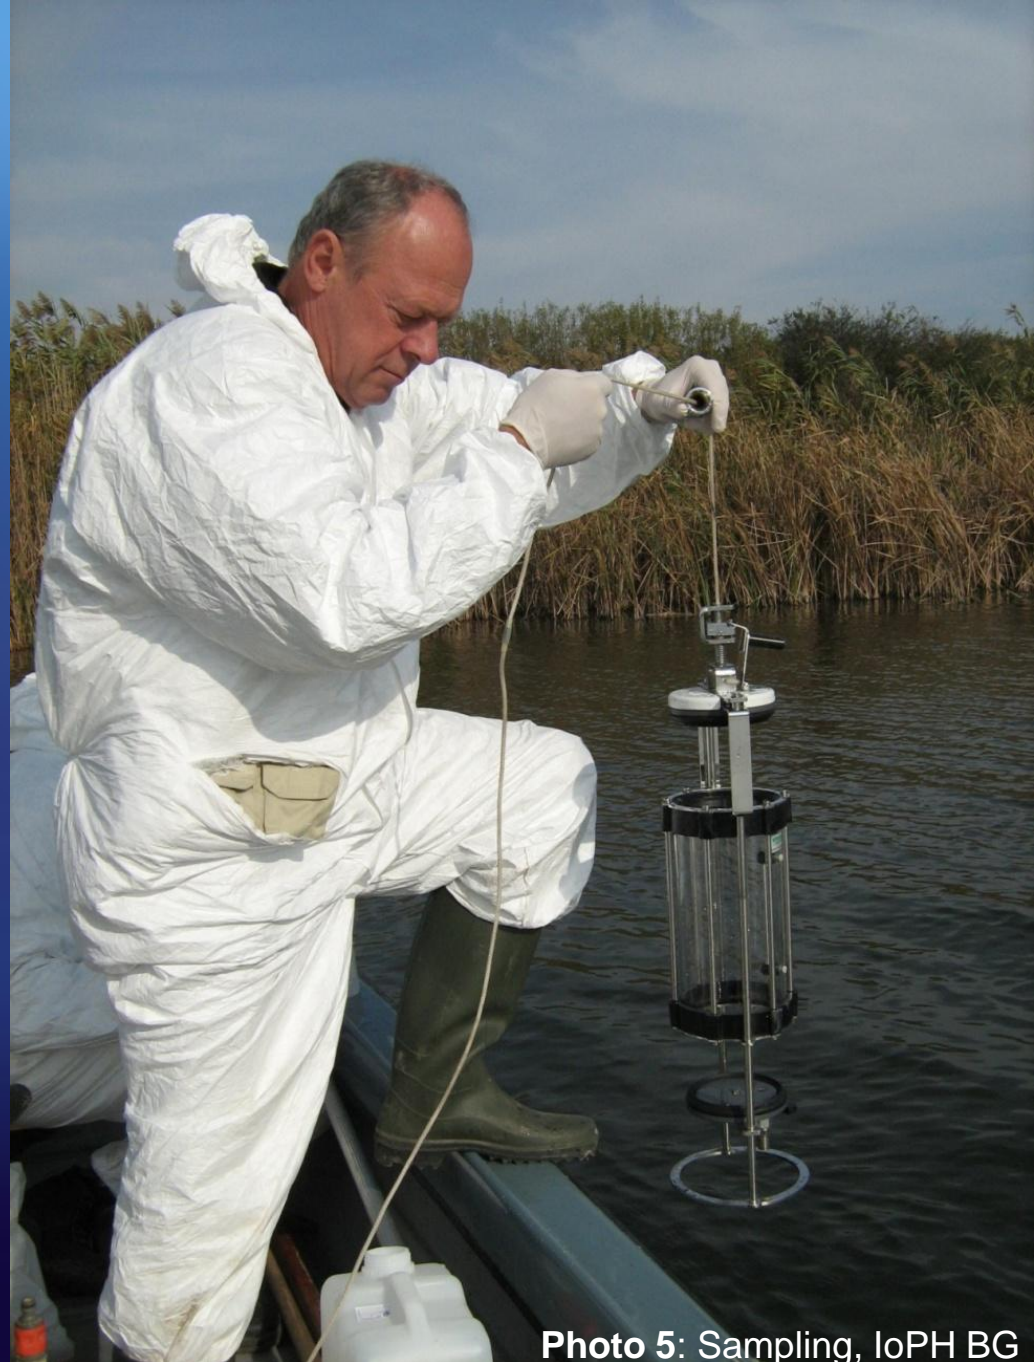
Photo 5: Sampling, IoPH BG
